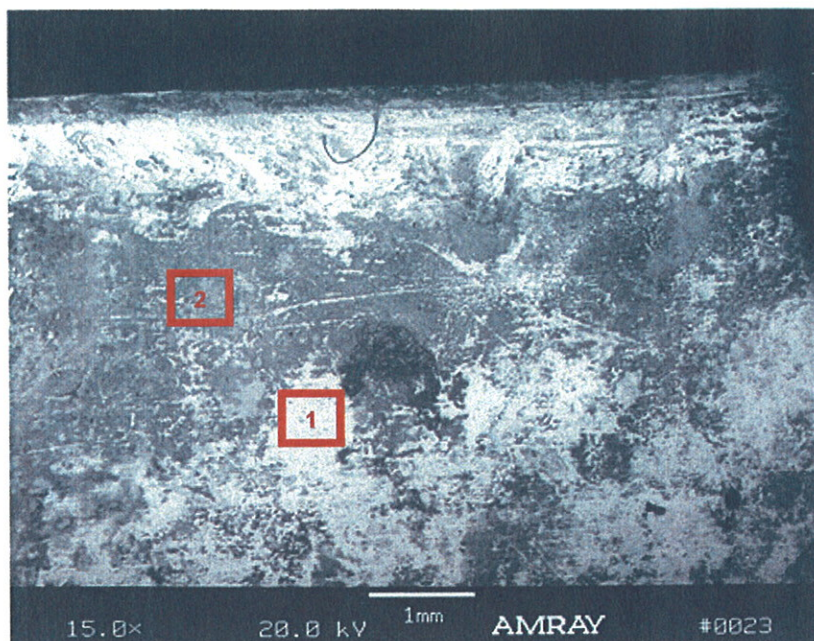
Figure 28. Backscattered electron image of Joint Section 4. EDS spectra from the areas denoted by boxes 1 and 2 are shown in Figure 29 and Figure 30.

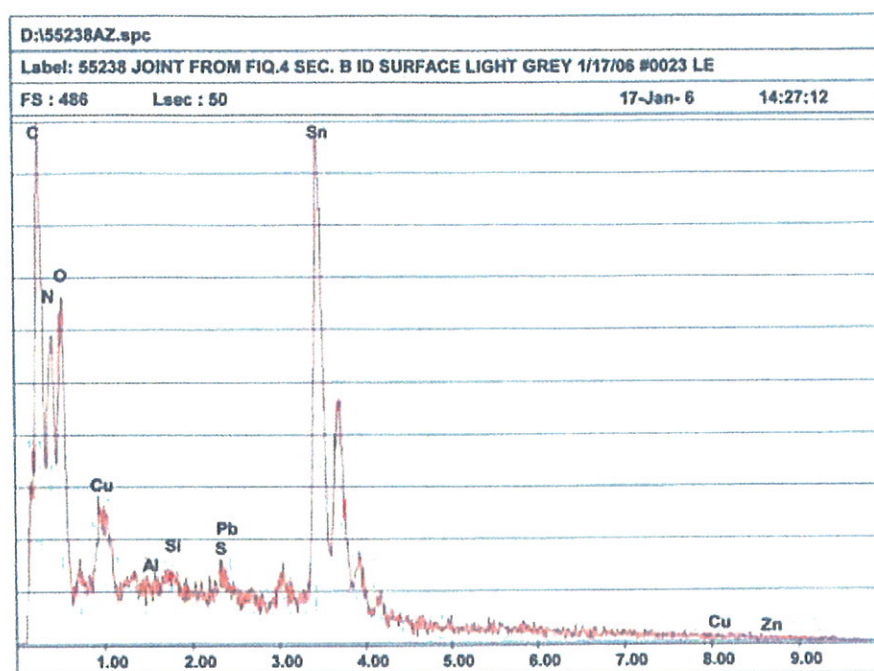
Figure 29. EDS spectra acquired from the region denoted by red box #1 shown in Figure 28.

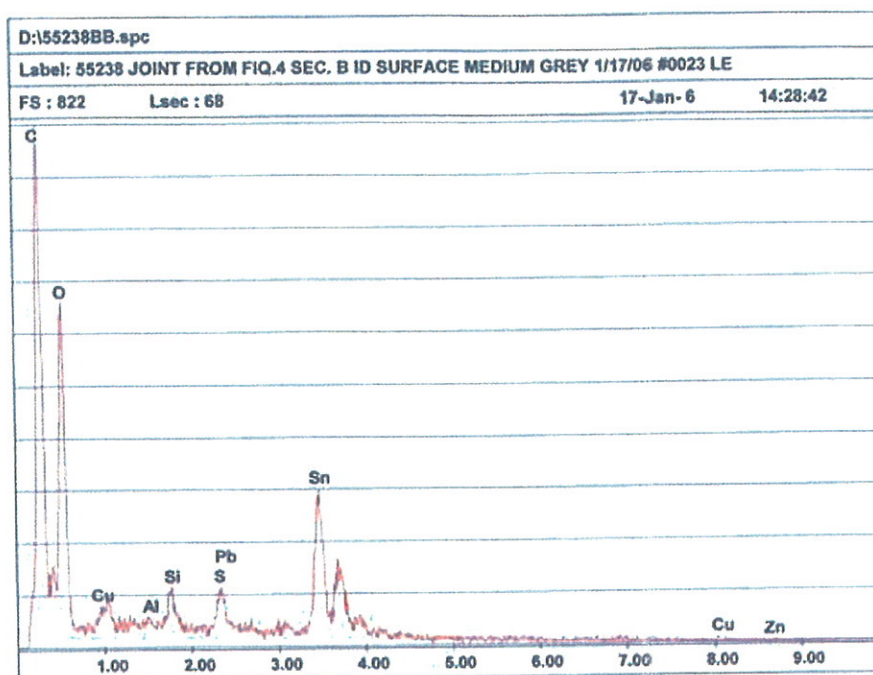
Figure 30. EDS spectra acquired from the region denoted by red box #2 shown in Figure 28.

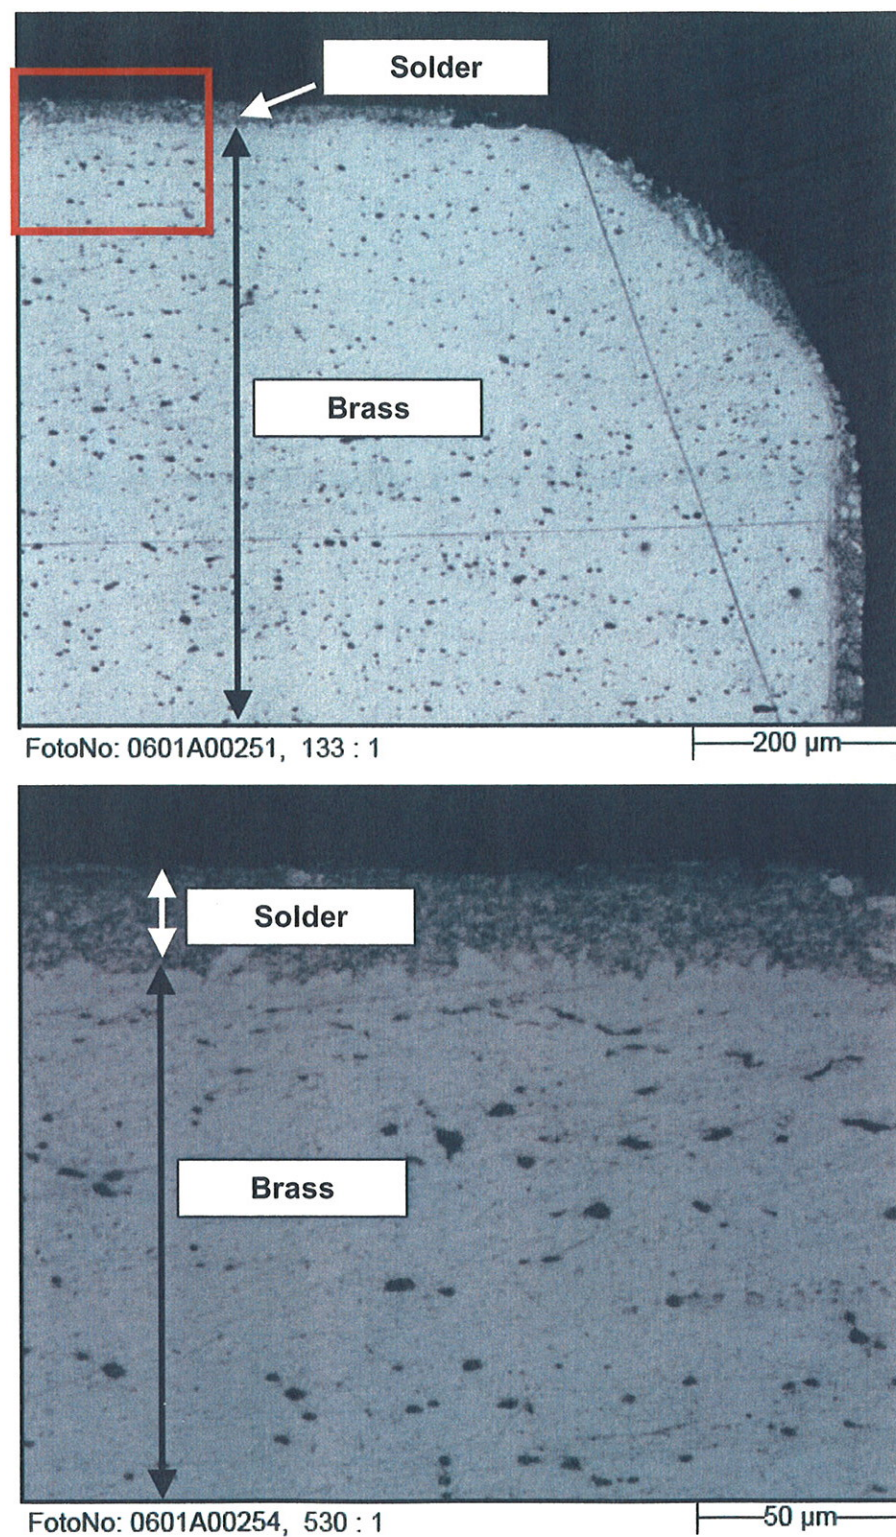
Figure 31. Optical photomicrographs showing the cross-section of the brass fitting, Joint Section 4.
